TECHNICAL REPORT SL-81-4

TEST AND ANALYSIS OF UPGRADED ONE-WAY REINFORCED CONCRETE FLOOR SLABS

Mark K. McVay

Structures Laboratory
U. S. Army Engineer Waterways Experiment Station
P. O. Box 631, Vicksburg, Miss. 39180

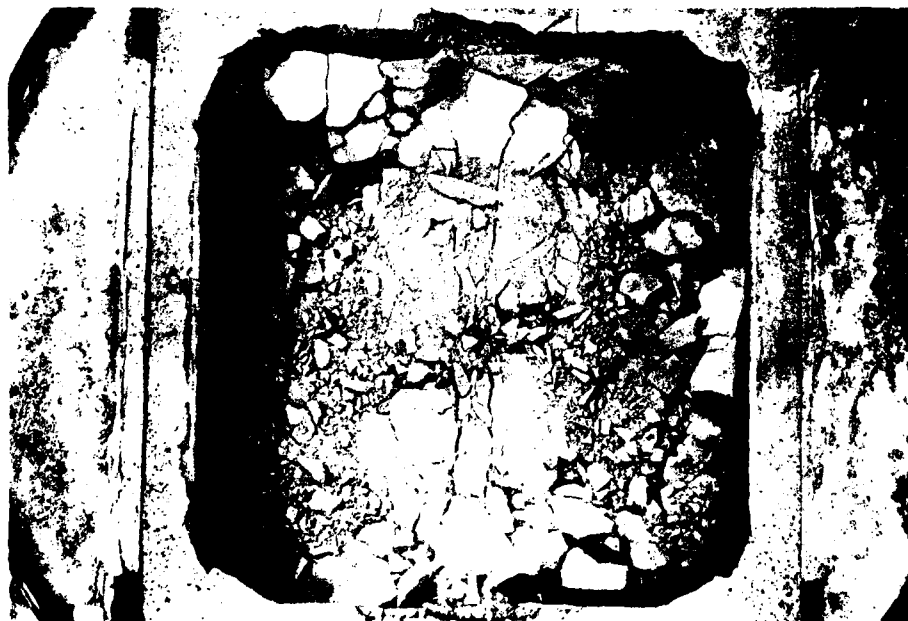
This test was to have been subjected to an average overpressure of 16 to 17 psi on the floor system, which was believed would barely fail the slab panels. But the wrong size Primacord was mistakenly used, and the resulting peak overpressure was 25 to 35 psi instead. The 25-g/ft Primacord is orange with one stripe on it and the 40-g/ft Primacord is orange with two stripes on it. The 40 g/ft was mistaken for the 25 g/ft and used instead. The result was a catastrophic failure of the floor system that threw the slab panels and center beam to the floor of the reaction structure as shown in Figure 5.4. The pressure gages lying underneath the floor section started measuring pressure at about 9 ms after zero time. The strain gages all measured very large strains within 10 to 40 ms. The strain gages on negative reinforcing steel in the slabs near the outside beams and girders reached failure faster than the strain gages elsewhere in the slab panels. This was probably due to the slab panels failing in direct shear along the outside beams and girders. The strain gages in the center beam indicate that it experienced a high strain level at the center at about 6 ms and failed at about 35 ms. Examination of the structure in the close-up of Figure 5.5 indicates that these theories are correct. The slab panels appeared to fail in direct shear because the cut at the outside beams and girders was

straight with no appearance of crushed concrete, and the reinforcing bars appeared to have been sheared instead of necked down. The center beam appeared to have pulled out of the girders at each end and rotated, while the middle of the beam failed in flexure.

Figure 5.4 Top view of Test Structure 1 after shot SLAB 1B.

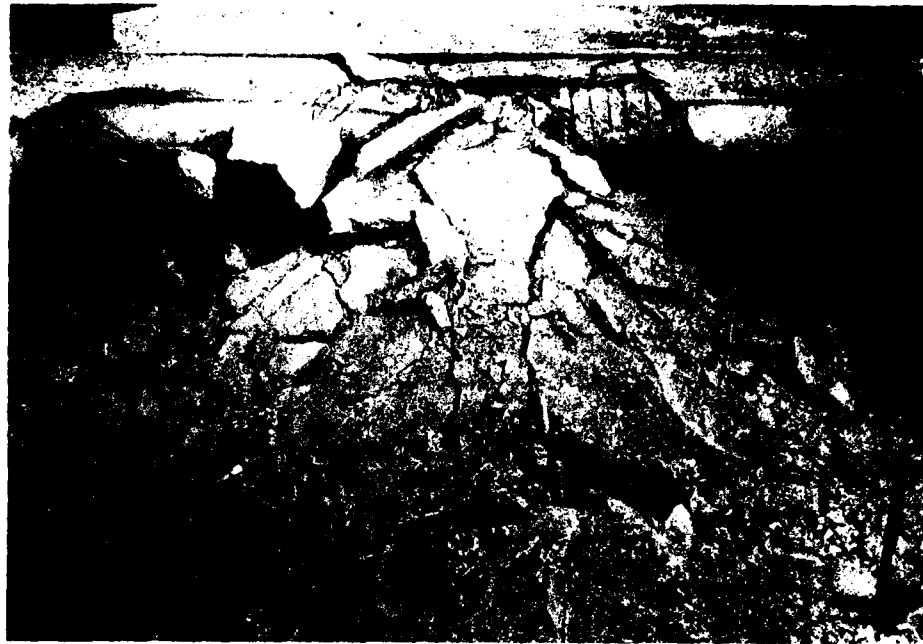
Figure 5.5 Closeup view of Test Structure 1 after shot SLAB 1B.

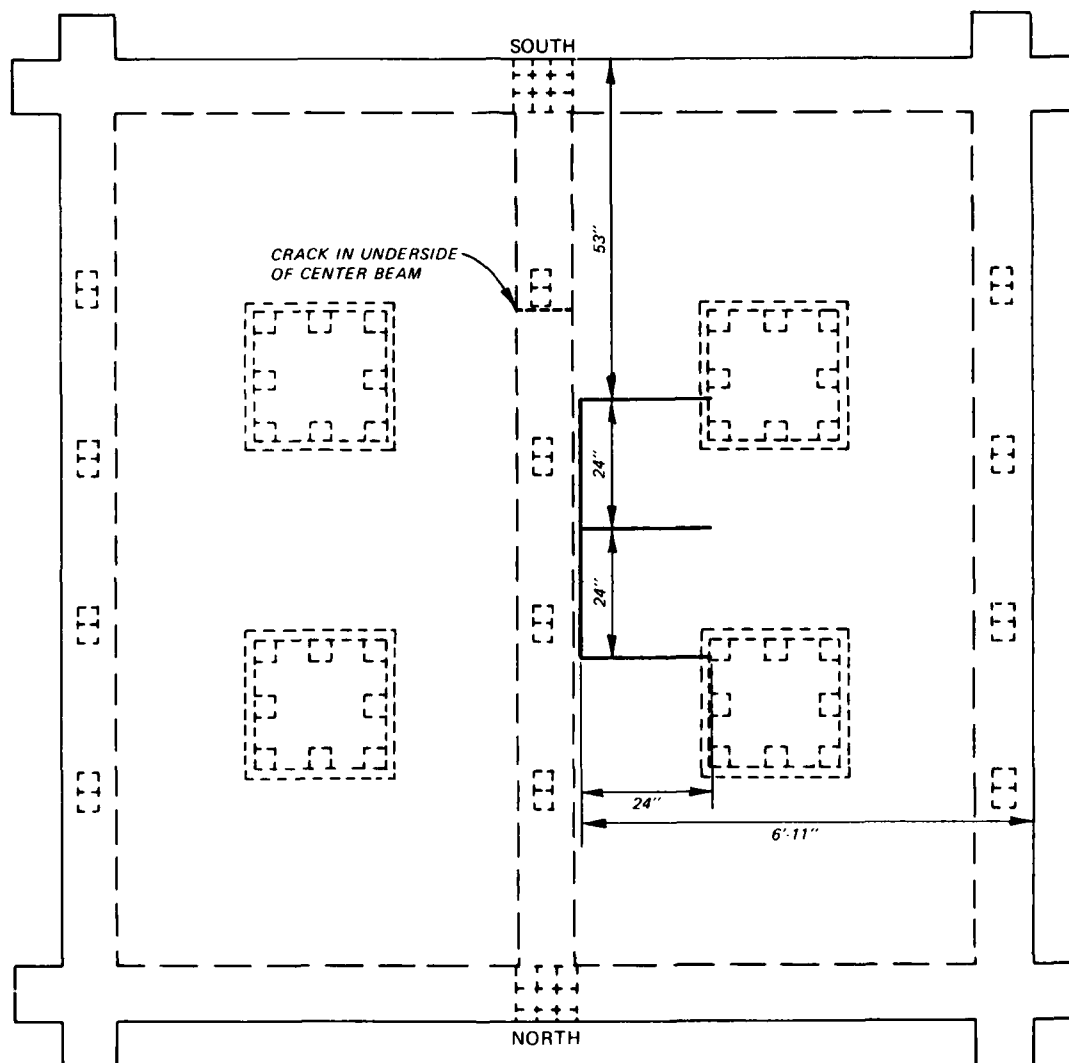
Figure 5.7 Crack patterns in Test Structure 2 after test 2B.

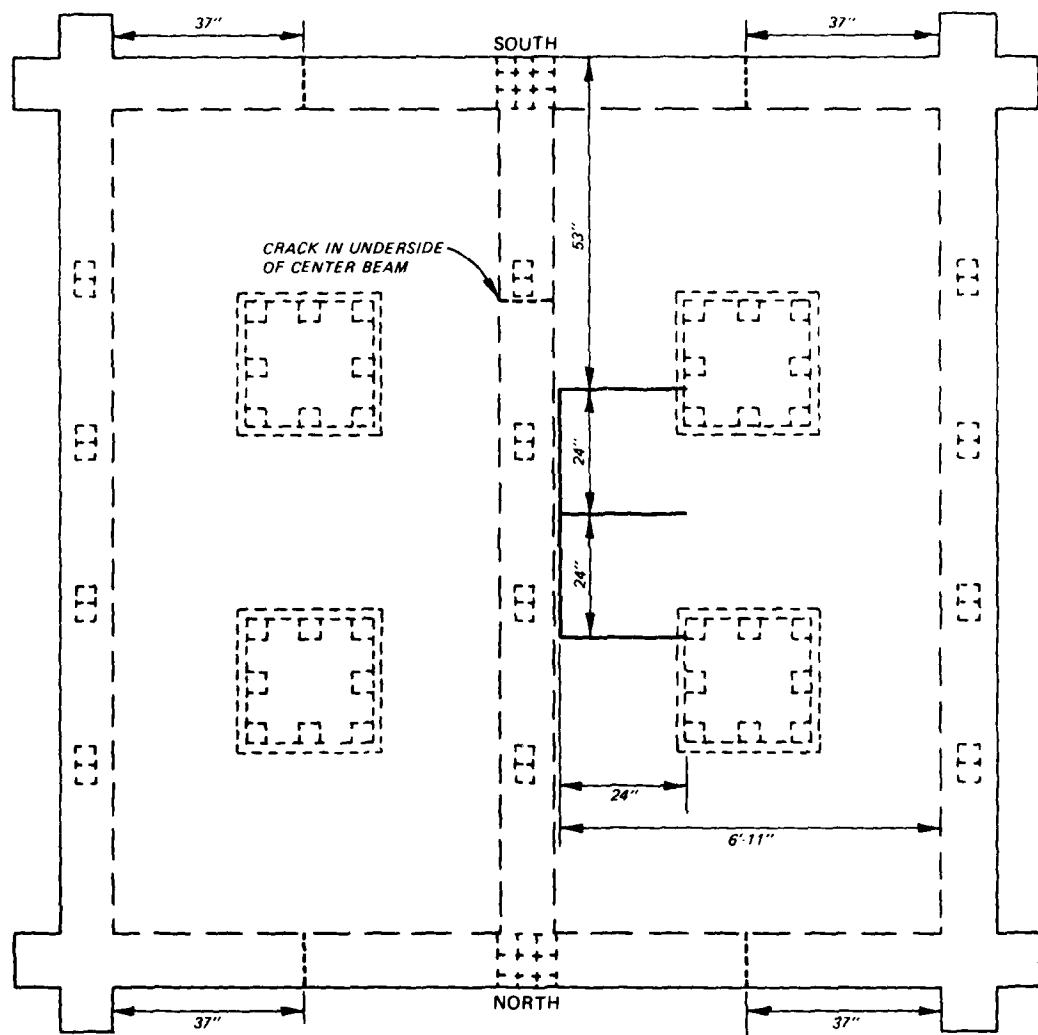
Figure 5.8 Crack patterns in Test Structure 2 after test 2C.

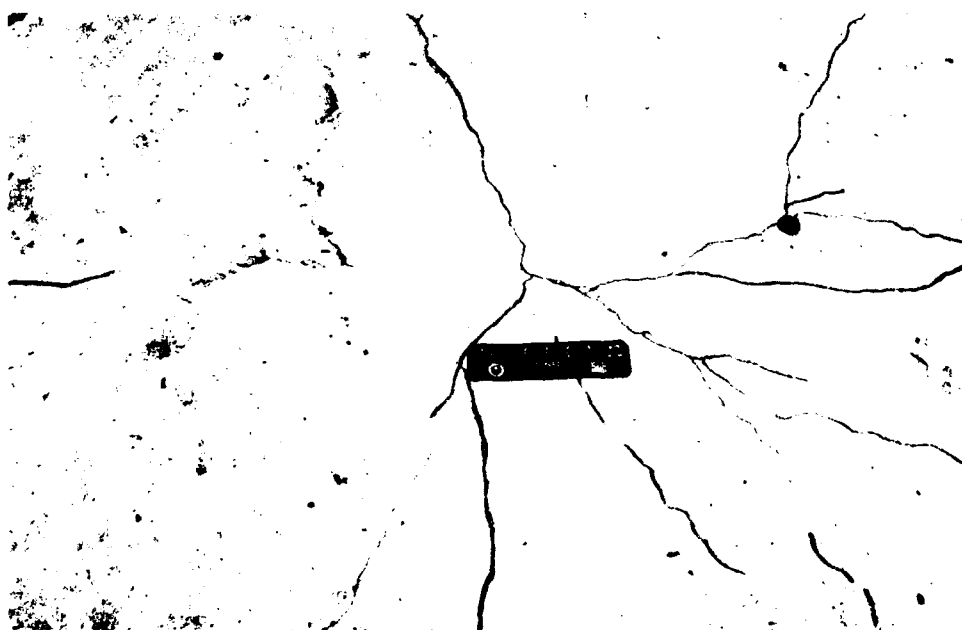
Figure 5.22 The concrete lifting up over the wooden column on load cell L1.

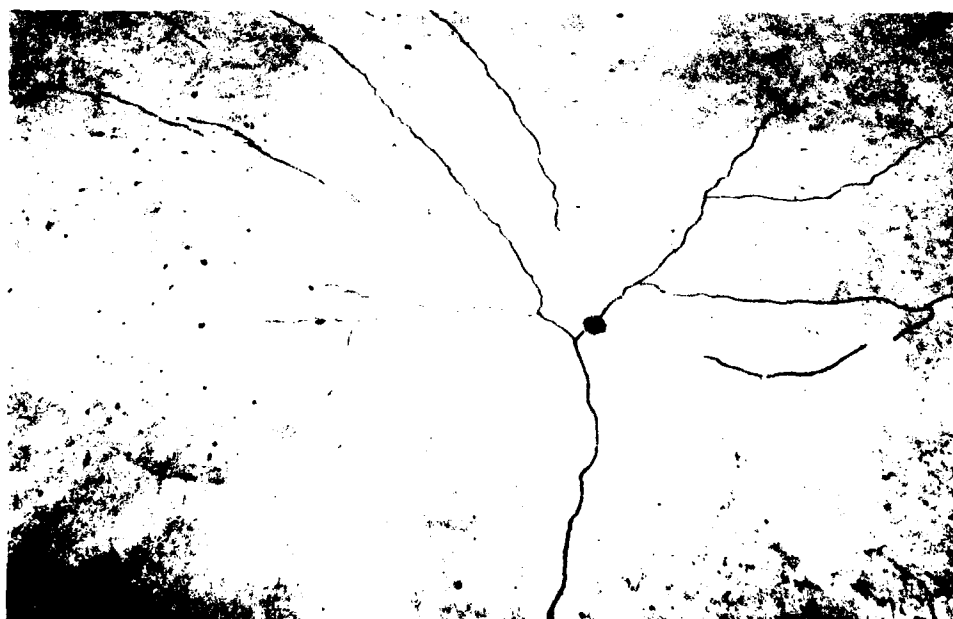
Figure 5.24 The concrete lifting up as the wooden post, on top of load cell L2, starts to punch through.

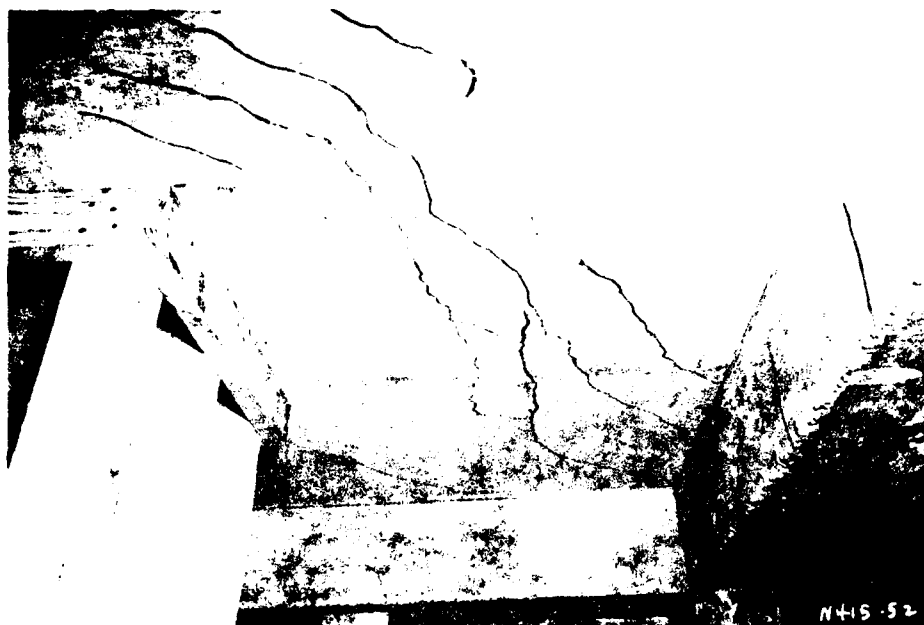
Figure 5.30 Cracks in the underside of the east slab panel at the south end.

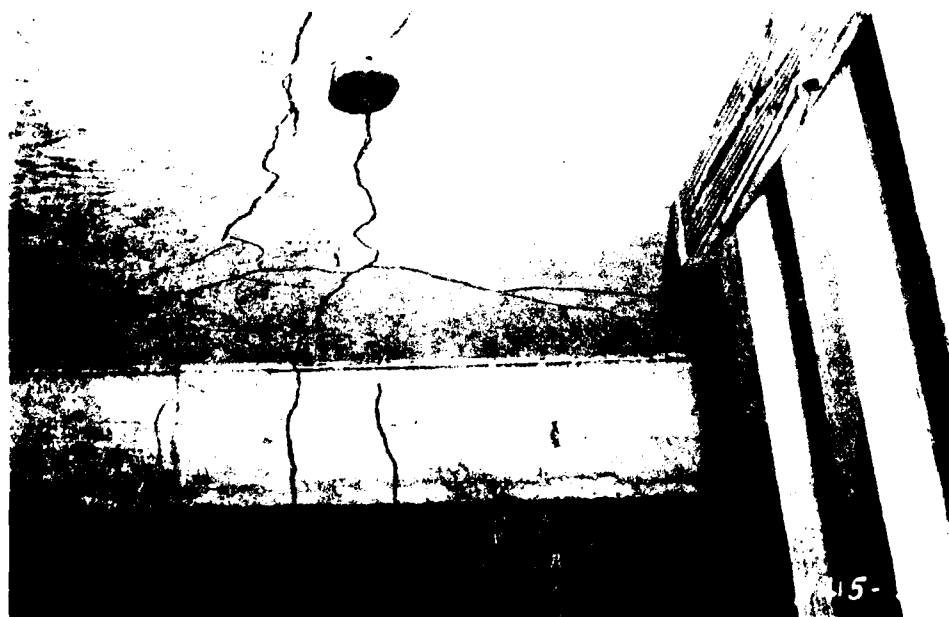
Figure 5.31 Cracks in the underside of the east slab panel at the center, after shot SLAB 2E.

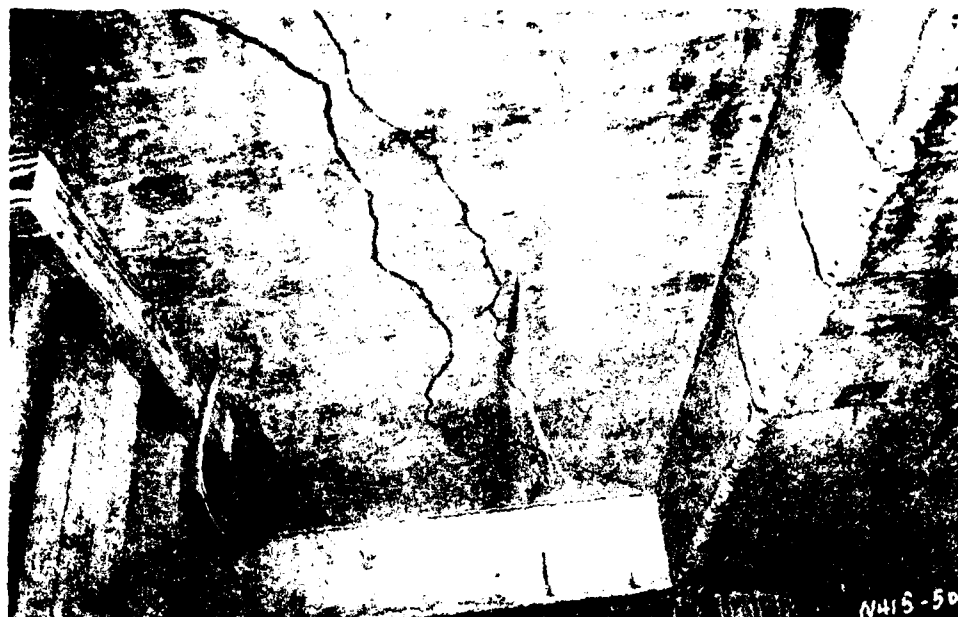
Figure 5.32 Cracks in the underside of the west slab panel at the north end after shot SLAB 2E.

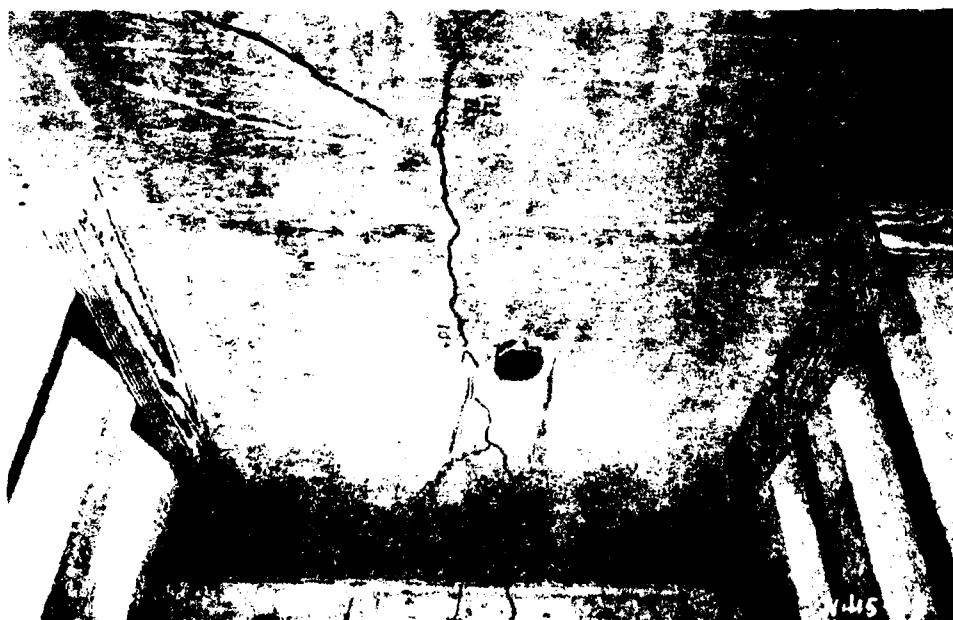
Figure 5.33 Cracks in the underside of the west slab panel at the center section after shot SLAB 2E.

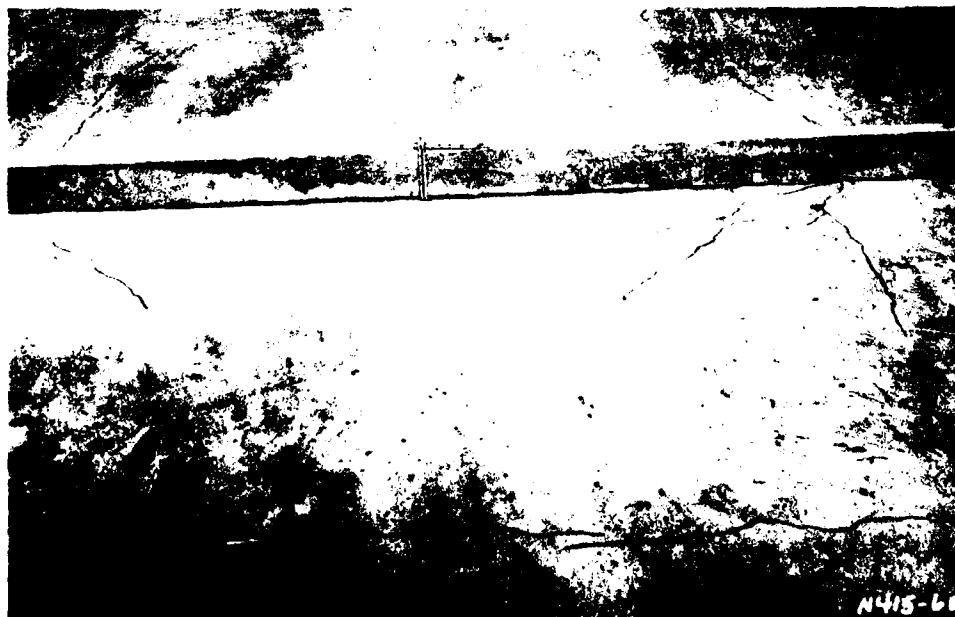
Figure 5.37 The permanent deflection of Test Structure 3 between the column rows upgrading the slab panels, after shot SLAB 2E.

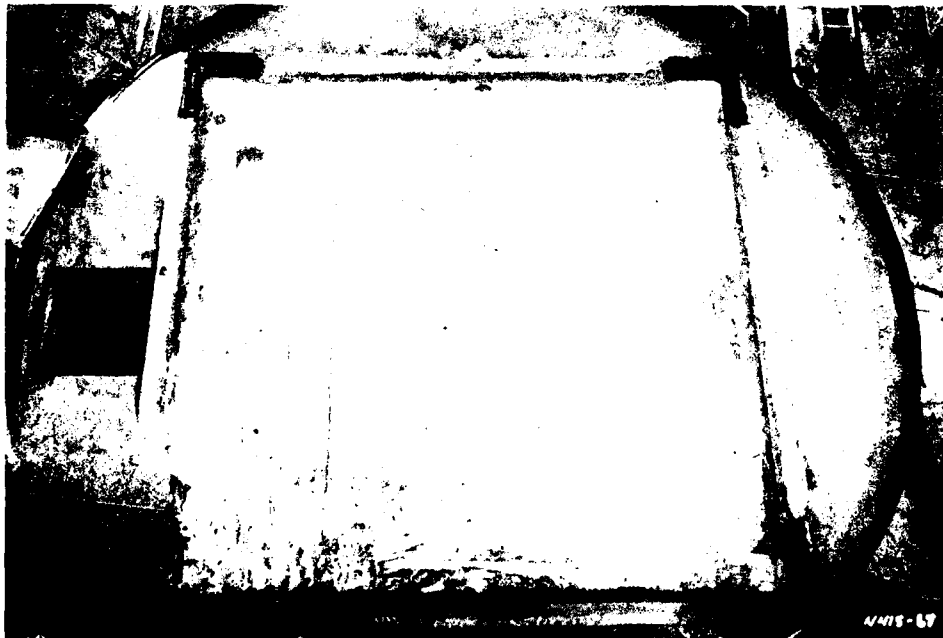
Figure 5.39 Cracks in the top of Test Structure 3 after shot SLAB 3A.

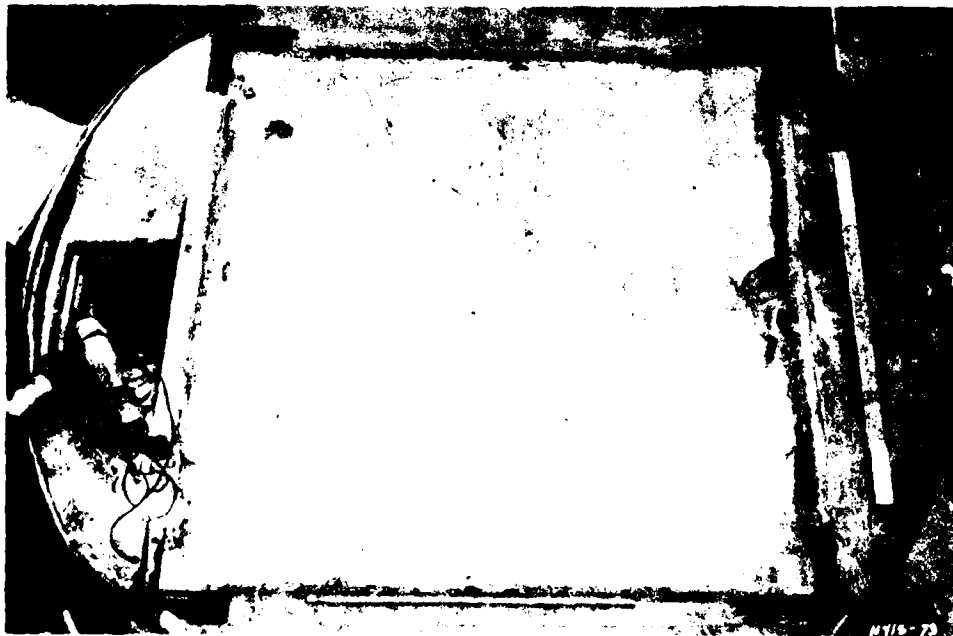
Figure 5.41 The crack pattern in the top of Test Structure 3 after shot SLAB 3B.

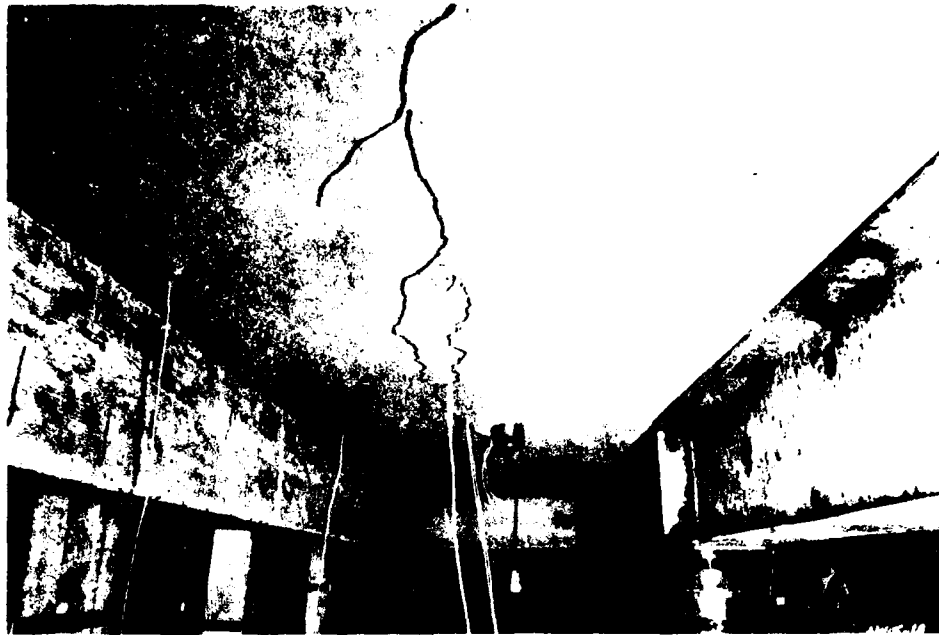
Figure 5.44 Crack pattern in the underside of the east slab panel between the center beam and an upgrading beam.

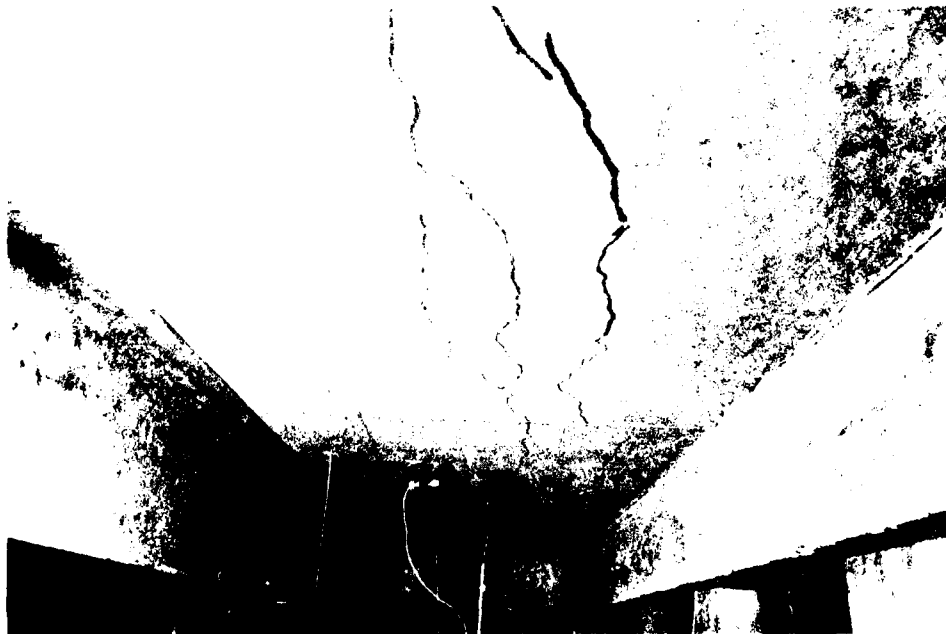
Figure 5.45 Cracks in the underside of the east slab panel, between the outside beam and the upgrading beam.

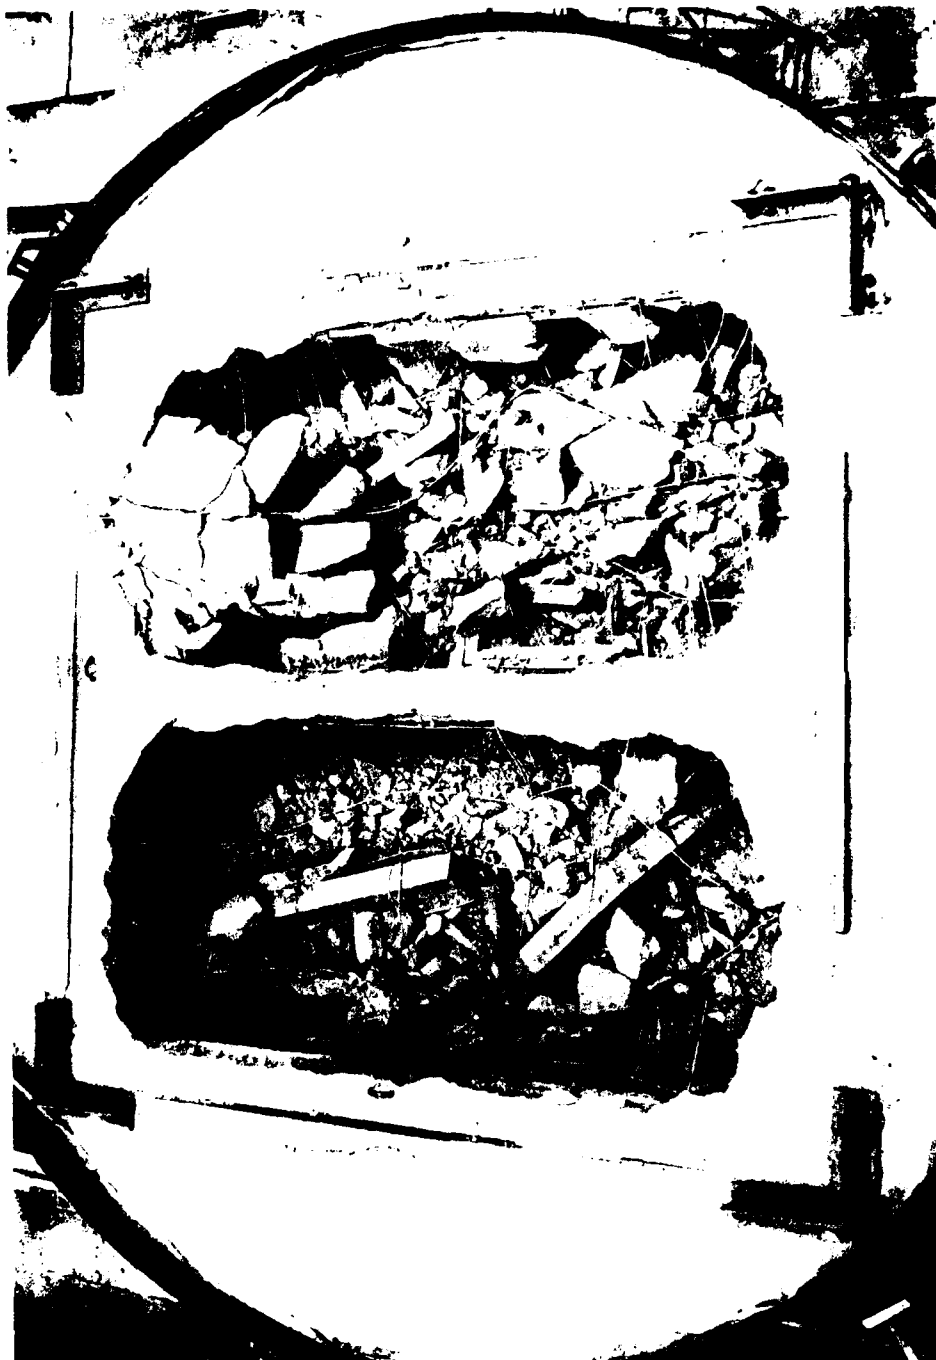
Figure 5.46 Test Structure 3 after shot blast No. 30.
